AFWAL-TR-81-4032

COMPILATION OF MECHANICAL PROPERTY DATA FOR IMPROPERLY QUENCHED (SOFT)
ALUMINUM PLATES

July 1981

Final Report for Period August 1979 - October 1980

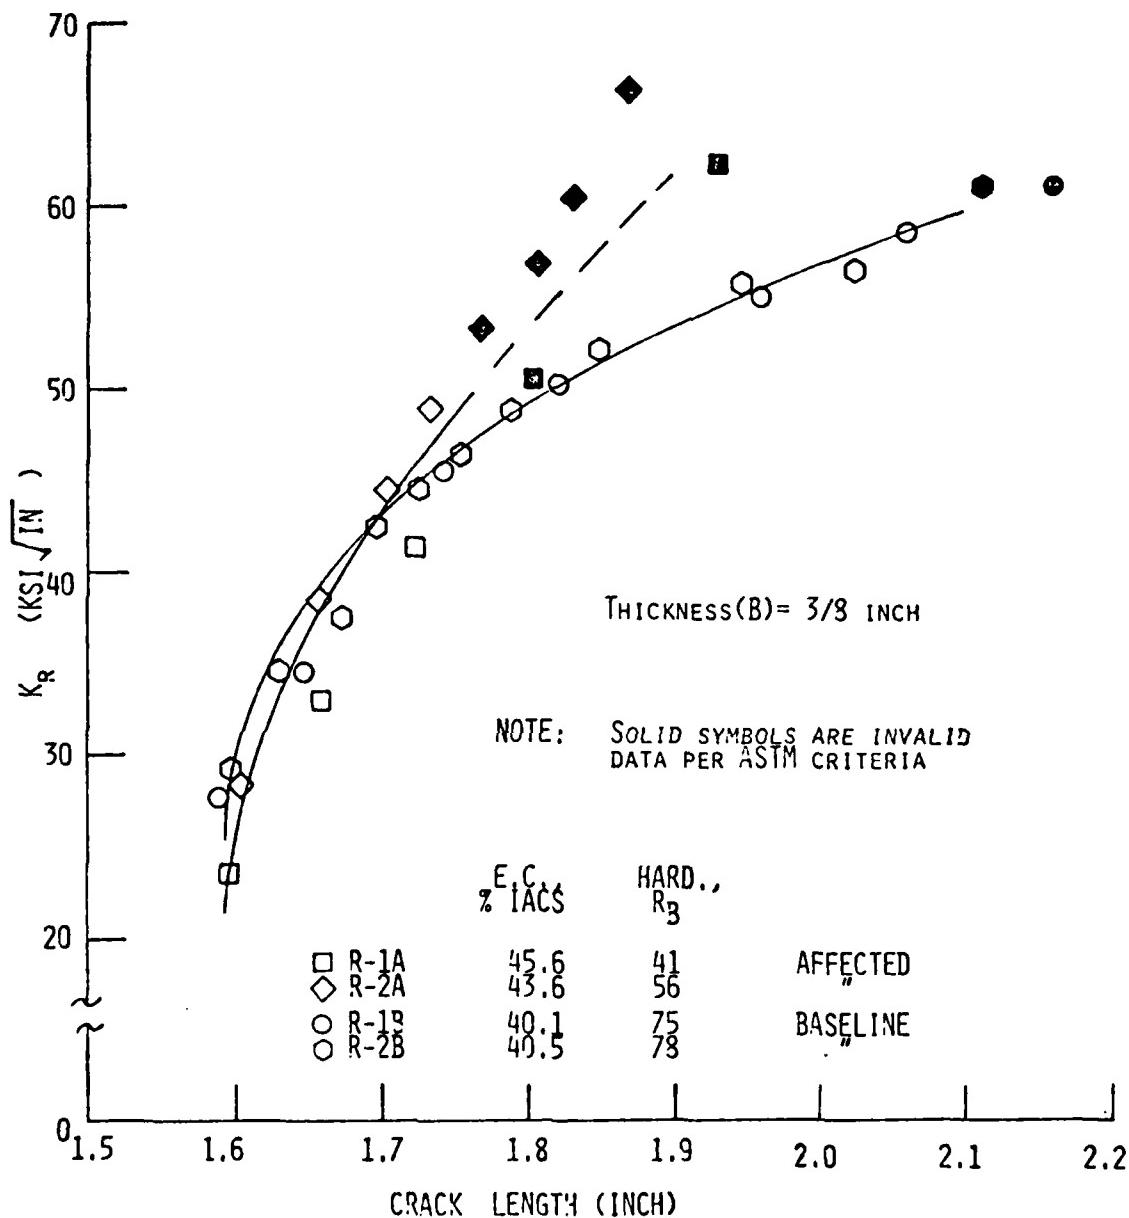
Figure 3. R-Curve Fracture Toughness Data, 2124-T851 5-1/2" Aluminum Plate

Four inch wide compact type specimens were used to obtain the crack growth resistance curves for the 5-1/2 inch thick 2124-T851 plate as shown in Figure 3. The trend lines indicate there is not a loss in crack growth resistance and there might be some increase in the resistance curve for the soft material in this alloy and temper.

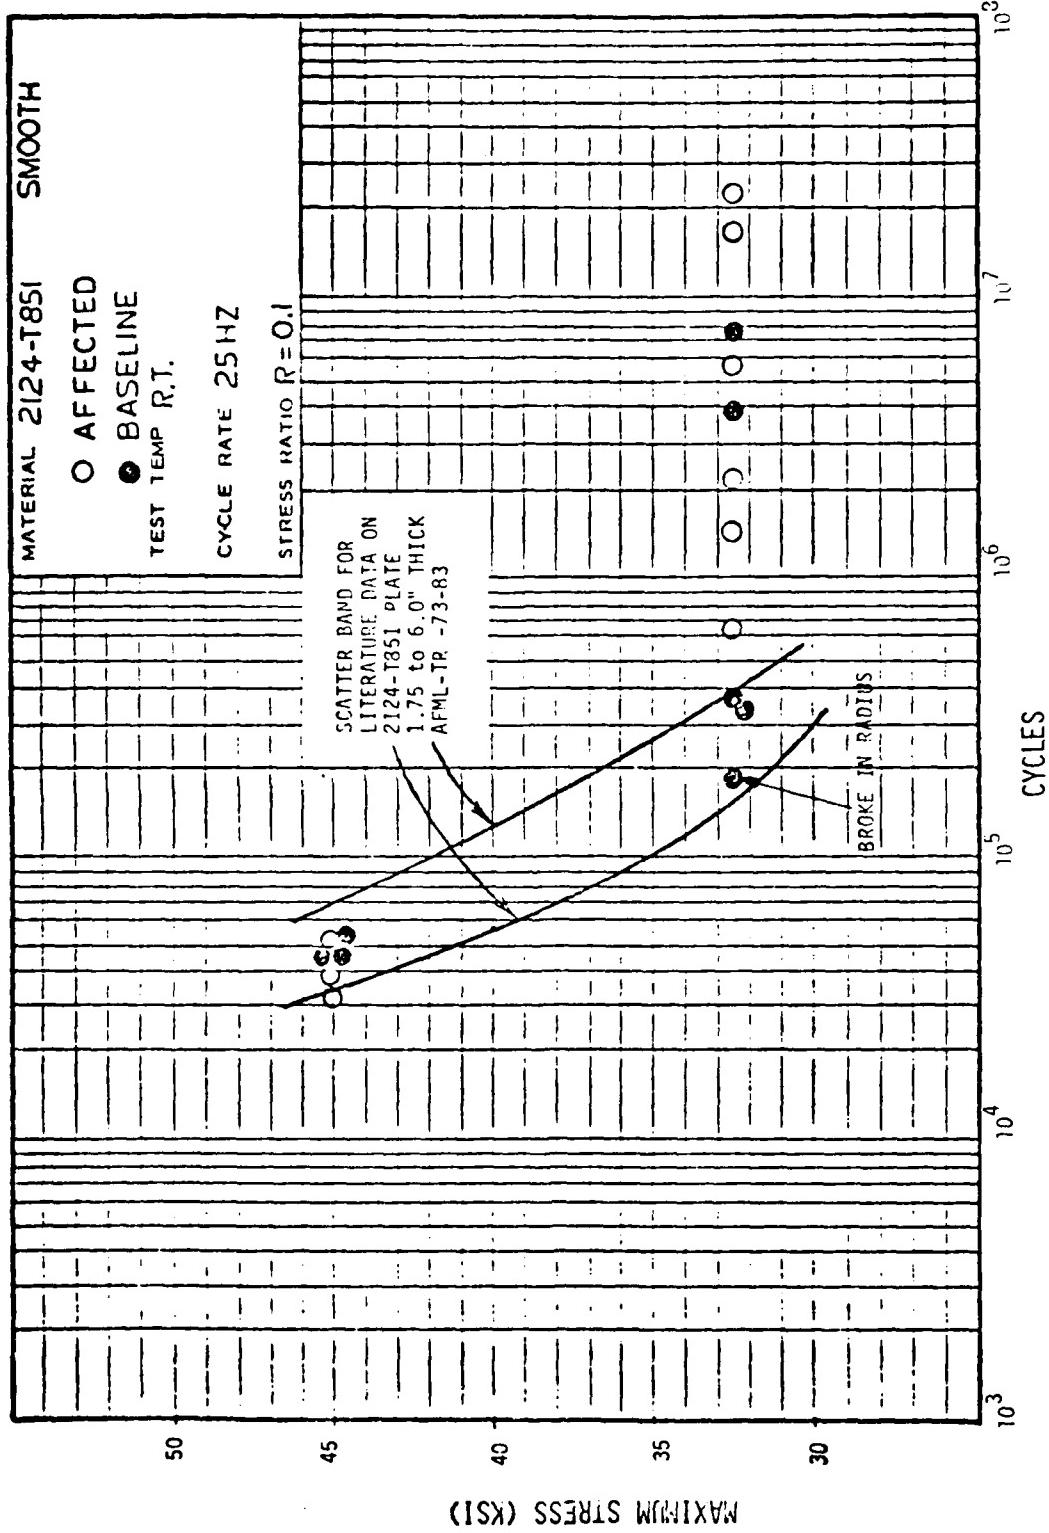
Figure 4. Smooth Fatigue Data for 2124-T851 5-1/2" Plate

The 5-1/2 inch thick 2124-T851 plate was checked for its constant amplitude fatigue properties. The results for smooth and notched tests are shown in Figures 4 and 5, respectively. The smooth data indicates there is little or no effect of softness on the unnotched fatigue life and the literature data scatter band confirms this. The notched results indicate there may be some influence on the fatigue life. To confirm this observation, the notched data in Figure 5 are replotted in Figures 6 and 7 as electrical conductivity and hardness versus cycles to failure where it can be readily observed that a strong correlation exists between NDI measurements and life, particularly at the higher stress. It can be concluded that fatigue properties of 2124-T851, at least in the notched condition, are affected by an improper quench.

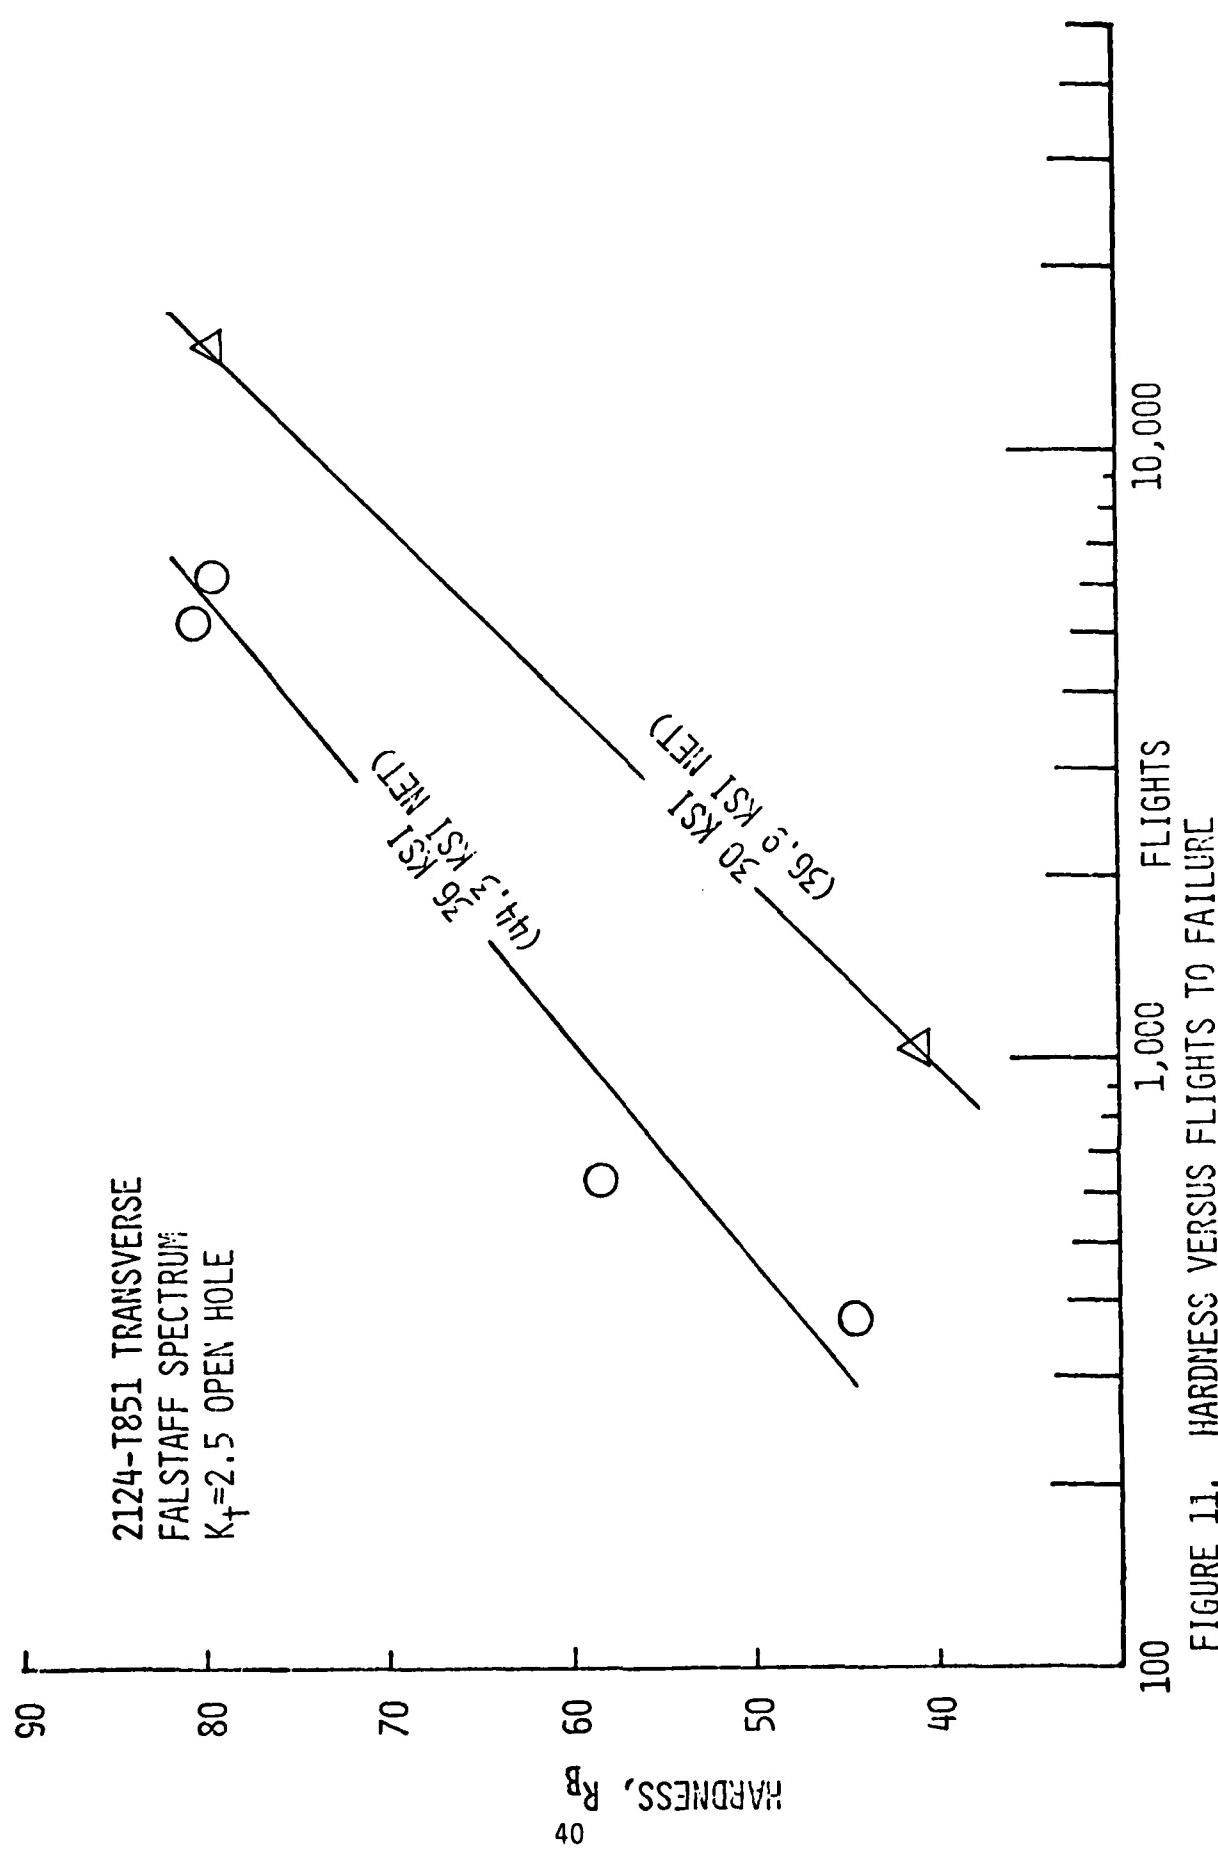
FIGURE 11. HARDNESS VERSUS FLIGHTS TO FAILURE

Notched spectrum fatigue specimens with transverse orientation were machined from the broken halves of the R-curve specimens. The results in Figures 11 and 12 are presented as NDI measurements versus flights to failure. The spectrum used was a standardized spectrum which was developed by several European countries using flight recordings from a number of aircraft. It is known as FALSTAFF, Fighter Aircraft Loading STAndard For Fatigue. It can be seen in the figures that a strong dependence exists between flights to failure and the NDI measurements (which are indicators of strength) which, of course, substantiate the findings from the notched constant amplitude tests.

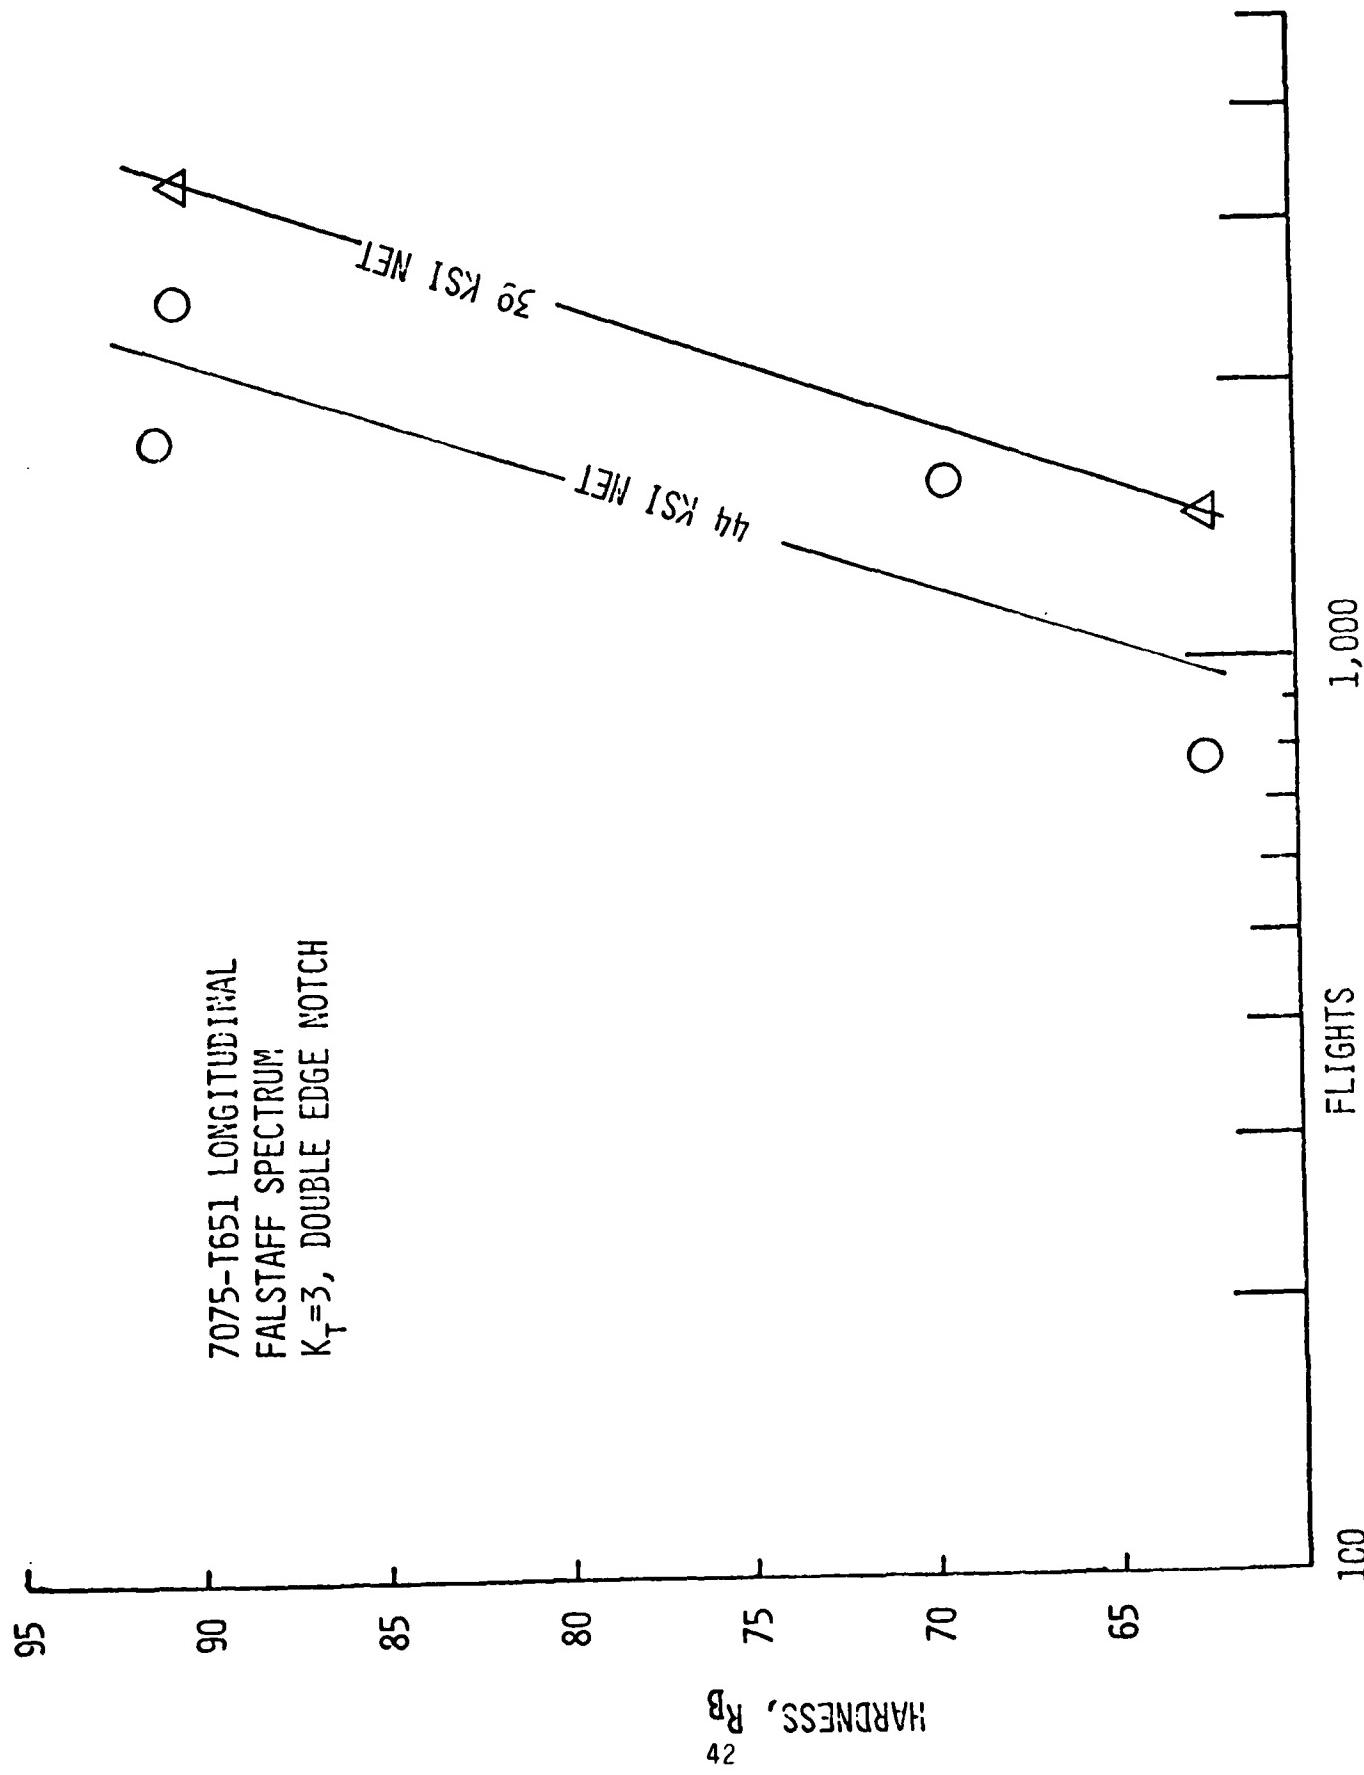
FIGURE 13. HARDNESS VERSUS FLIGHTS TO FAILURE

Specimens from these plates were subjected to the same spectrum as discussed in the foregoing and the results are shown in Figures 13 and 14. Correlations between the NDI measurements and flights to failure are not as strong for these data. The trend lines are much steeper, demonstrating less of an effect of the softness than for the 2124. This is the same as was concluded for the constant amplitude data; soft 7075-T651 experiences less of a loss of fatigue life than 2124-T851.

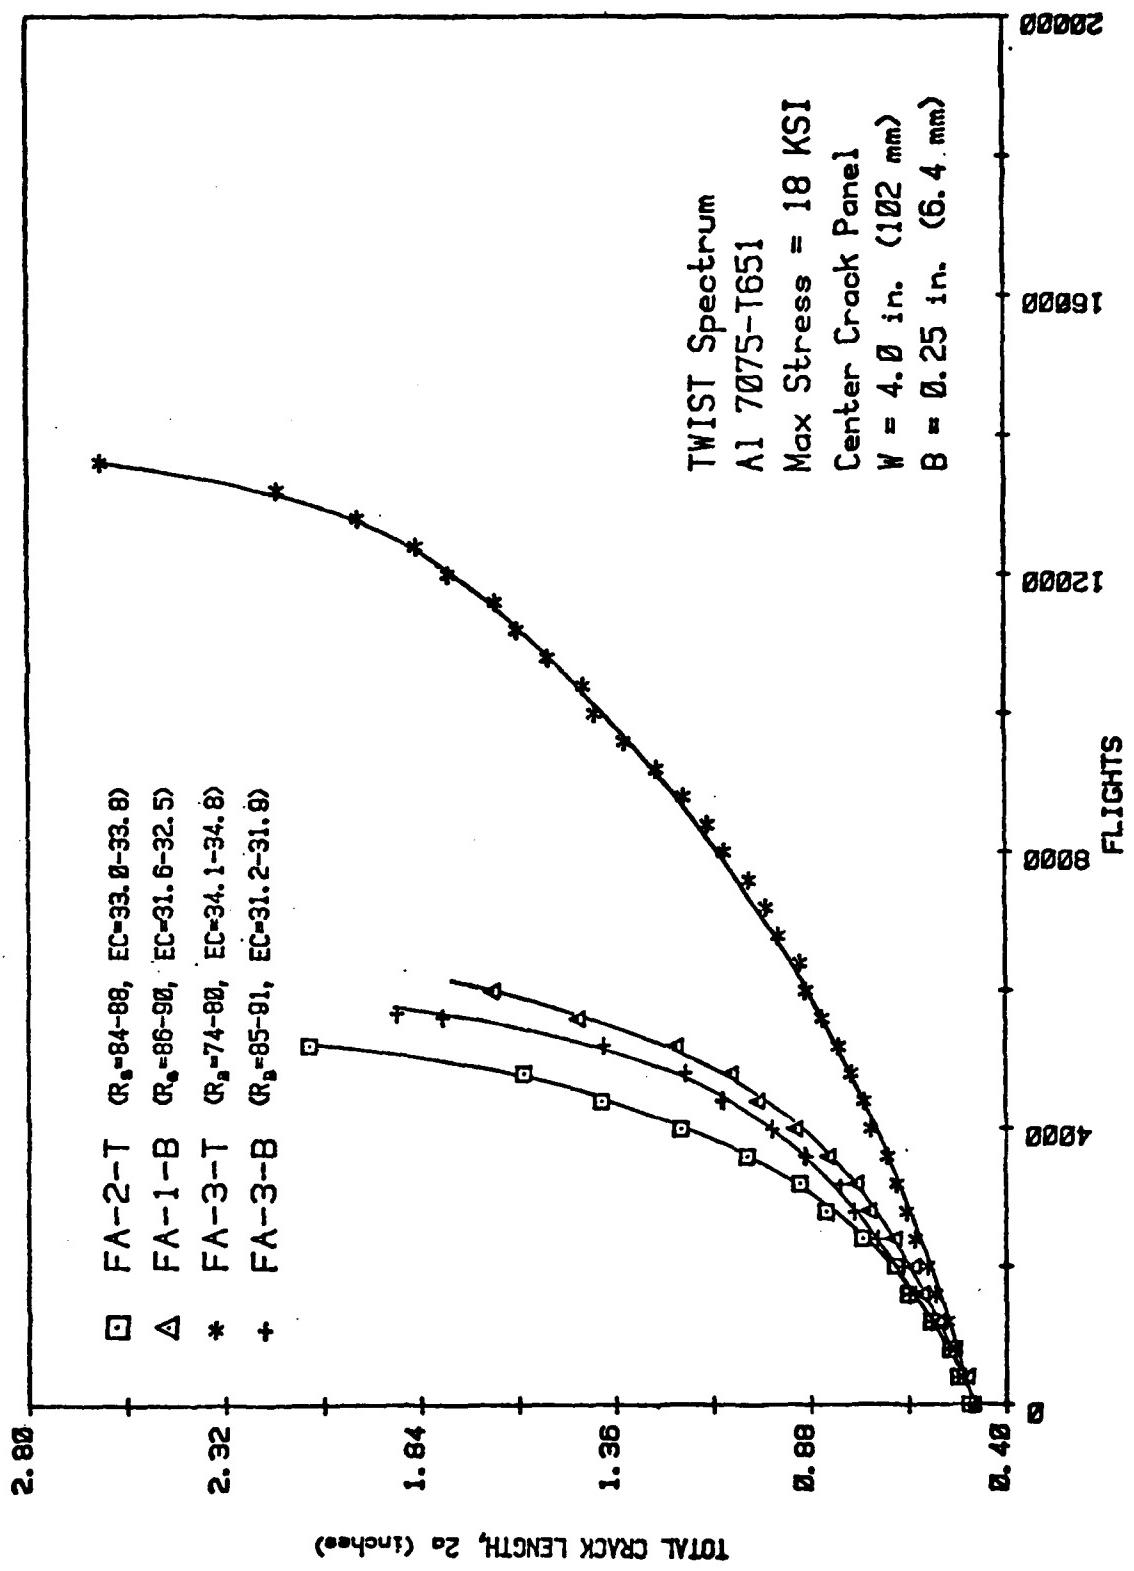
Figure 20. Total Crack Length, $2a$, versus Flights for 7075-T651 Aluminum Plates:
Max Spectrum Stress = 18 KSI

The TWIST spectrum was used to test 7075-T651 center cracked panels at two different maximum spectrum stress levels as noted in Figures 20 and 21. The results are completely reversed from those obtained for the 2000-series alloys shown previously. That is, the soft 7075-T651 had longer lives and slower growth rates. It is apparent from these results, coupled with the fatigue results presented previously, that soft 7075-T651 presents less of a threat than 2024 or 2124 to structural integrity in fatigue applications.

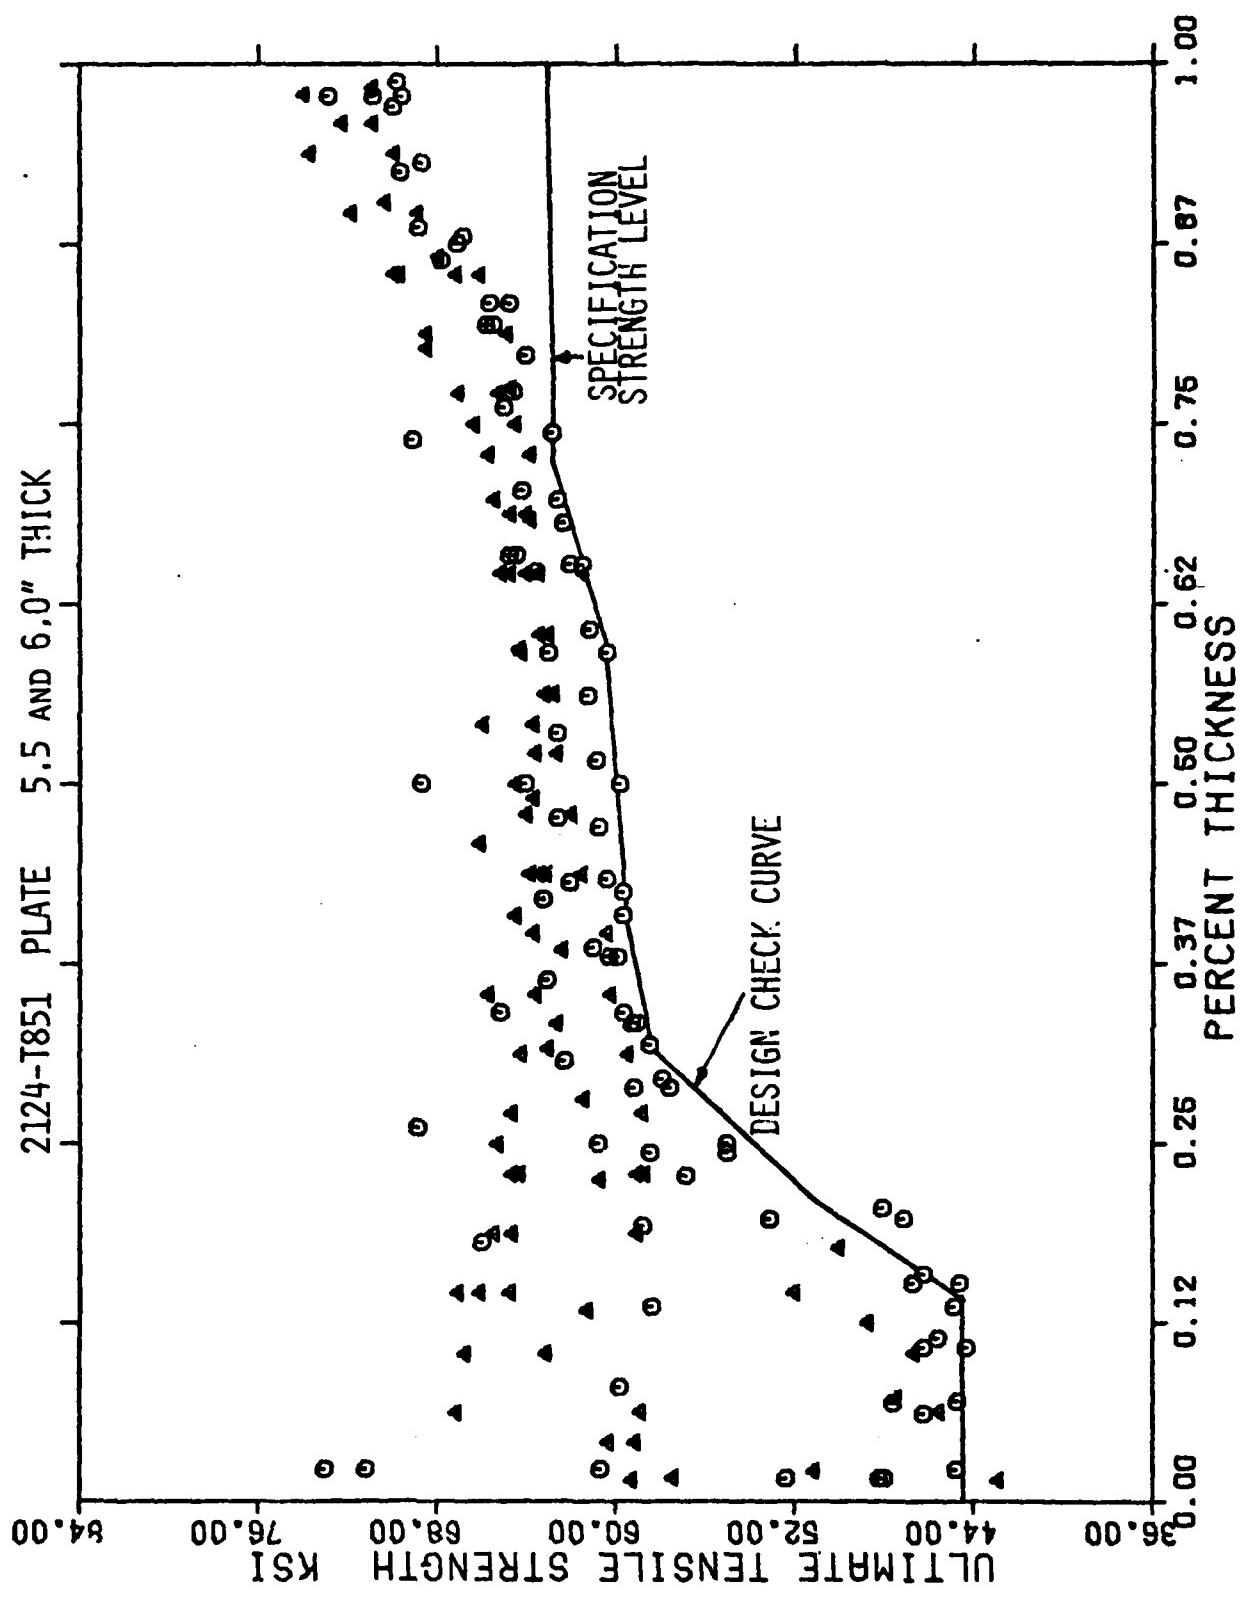
Figure 38. Ultimate Strength Design Check Curve

A method of presenting the through the thickness degradation is shown in Figures 38 and 39. A lower bound line on the data was used for worst case structural analyses by ASD personnel. The percent thickness curves are displayed for the 5-1/2" to 6" thick 2124-T851 alloy only. Many thicknesses were involved in each alloy and each range required a separate evaluation. The thick plate 2124 had the most input data and was typical of the types of summary plots furnished to ASD. Some late arriving data can be seen to fall below the Design Check Curves, but the overall effect of these additional data did not justify making changes to these curves.
